Presented at CORROSION/99 Paper No. 99342
Copyrighted © by NACE International
Corrosion Testing Laboratories, Inc. 60 Blue Hen Drive, Newark, DE 19713

ANT NEST CORROSION -- EXPLORING THE LABYRINTH

Peter Elliott
Corrosion Materials Consultancy, Inc.
P.O. Box 37
Colts Neck, NJ 07722

Richard A. Corbett
Corrosion Testing Laboratories, Inc.
60 Blue Hen Drive
Newark, DE 19713

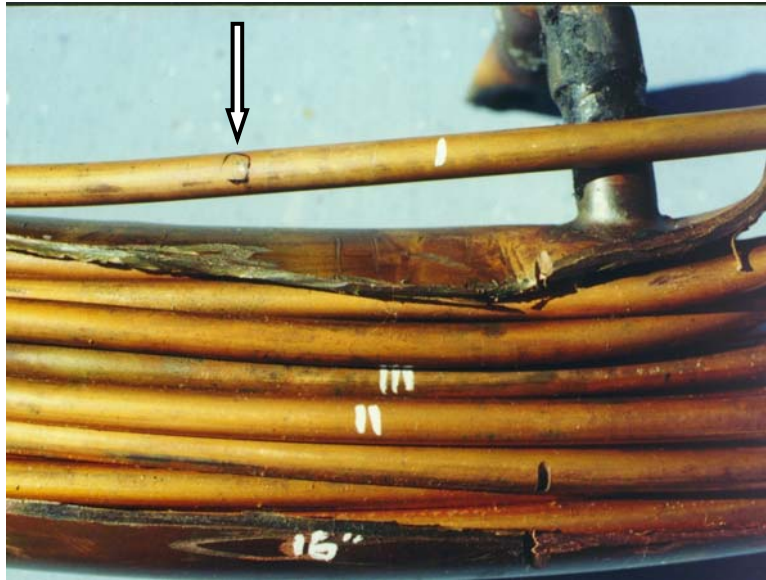
Background. Small bore, 3/16" OD copper tubes were failing within a few months service as a result of pin-hole pitting on the inside diameter (ID) air-side of the heat exchanger tubes, Figure 1. Quench water used following brazing or for leak testing was suspect in that the water was infrequently changed, and the facility (originally) had less than rigorous control on their assembly line and warehousing practices.

Figure 1. Ant-nest corrosion in 3/16-inch diameter copper heat exchanger tubes after approximately two months service. Arrow points to pin hole.

Considerations. Radical changes were made to the fabrication shop conditions and methods for warehousing the final heat exchanger assemblies. The frequency of failure was reduced significantly, although not entirely eliminated. The damaged areas were commonly purple in color.

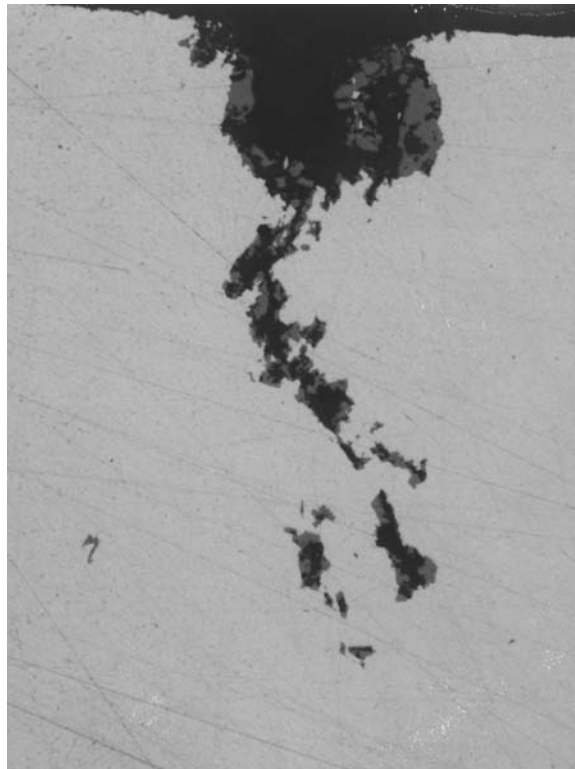
Features. The copper ID surfaces, revealed by splitting tubes longitudinally, were typically dull-black in appearance, sometimes with an oily-film present. Cross sections revealed ant nest corrosion damage, Figure 2, extending deep into the tube.

Figure 2. Cross-section showing ant nest corrosion in a heat exchanger tube after 6 weeks from fabrication. (original magnification 200X)

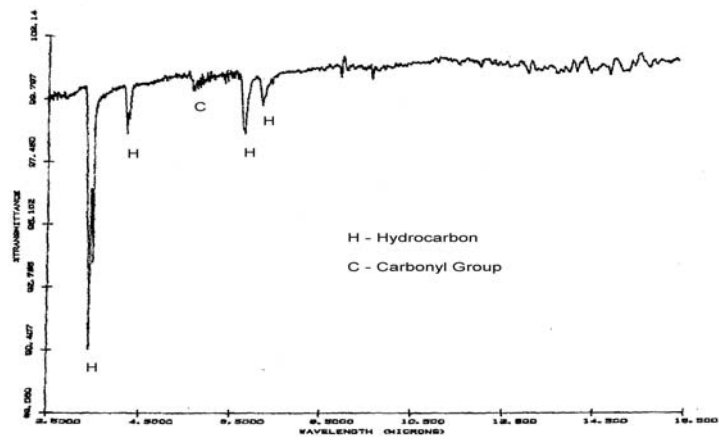
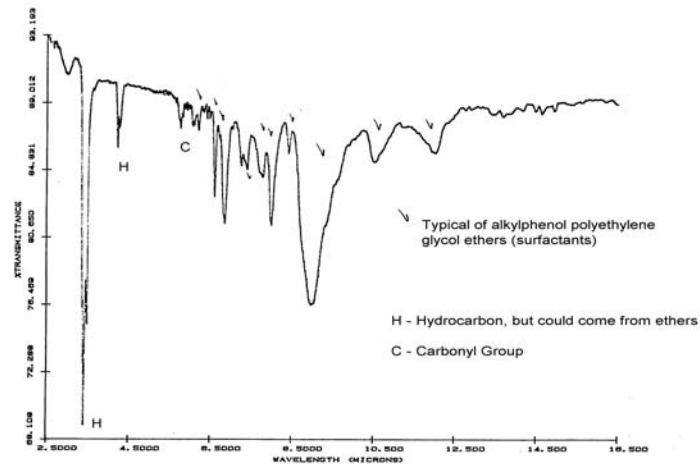
FTIR (Fourier Transformation Infrared) analysis was conducted on wash-down products released from selected tube lengths using an acetone rinse. The FTIR spectra revealed bands due to hydrocarbon materials with a small amount of carbonyl functionality; typical of petroleum-based lubricants. Further spectra revealed alkylphenol-EO adducts (alkylphenol polyethylene glycol ethers) which are non-ionic surfactants, Figure 3. No bands were detected from FTIR Spectra on the as-received tubes.

Figure 3. Infrared (FTIR) spectra of ID products

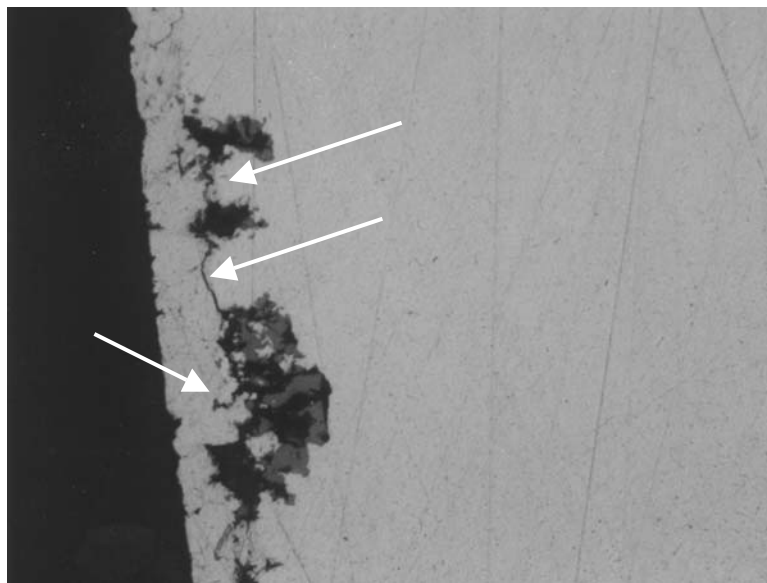
Of note in certain cross-sections was the presence of fine cracks bridging individual pitted areas, (Figure 4). This may indicate some local contributions from internal stresses in the material. It is noted that cracks are not a commonly reported phenomenon in ant nest corrosion.

Figure 4. Fine cracks (at arrows) inter-linking pits associated with ant nest corrosion.

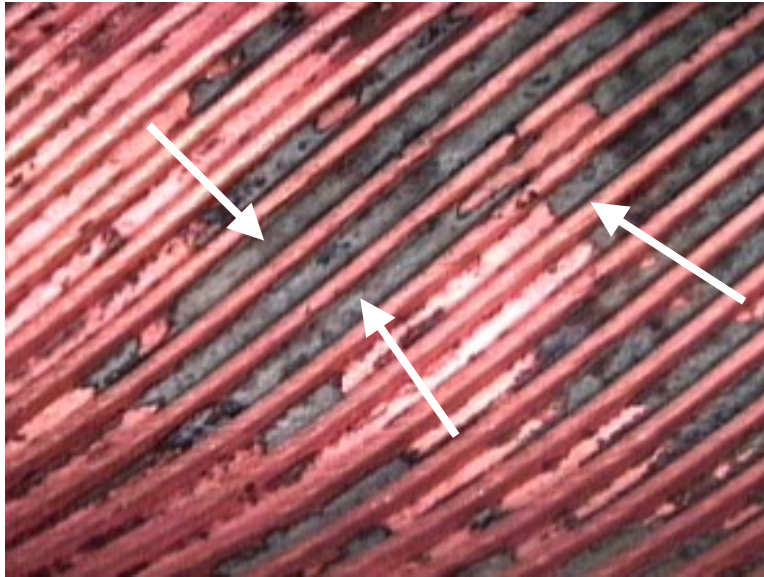
Features. In the as-received condition, the outside diameter (OD) surfaces of the tubes had a reddish-copper color with areas of random black staining. There was no obvious attack, even under microscopic examination. Longitudinal cutting of the tubes revealed the ID surfaces. Under the microscope, small bits of debris and sand particles were observed, and presumed to have come from the cooling tower water. A random black scale, Figure 5, was present which could not be removed by mere scrubbing with a firm toothbrush. Inhibited hydrochloric acid was employed to remove the deposits on the tube, however, the black scale resisted chemical cleaning. At 40X magnification, small pit-like features were observed in the midst of the black scale, Figure 6. Cross-sections revealed extensive ant nest corrosion extending through the tube wall, Figure 7.

Figure 5. Semi-cleaned condenser tube ID. Arrows indicate areas of black scale and pitting attack. (10X original magnification)

The tube mill and chiller manufacturer are addressing the issue of lubricants, but as yet no decision has been made to change these fluids. A more intense rinsing program has been initiated, with considerations to use copper inhibitors and hot air drying.

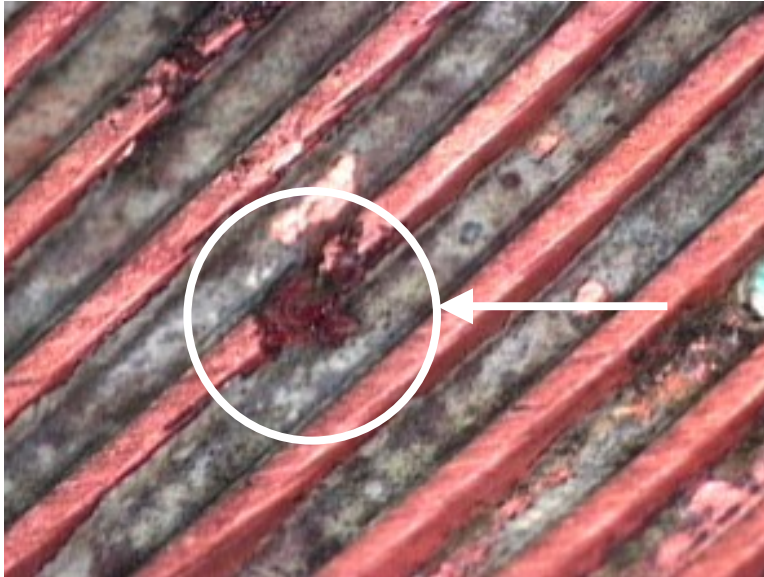
Figure 6. Semi-cleaned condenser tube ID. Arrow indicates area of substantial pitting attack. The rifled ridge is completely gone. (40X original magnification)

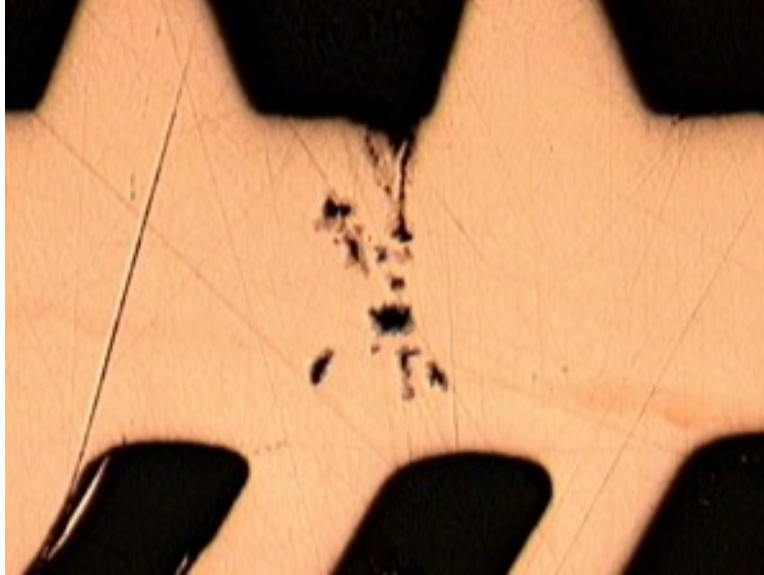
Considerations. It was reported, although not confirmed, that the black stains on the OD were present in the as-received condition from the tube manufacturer. It is known that the tube manufacturer, over the course of the last seven years had phased out from using a petroleum-based drawing / finning lubricant and chlorinated hydrocarbon degreaser to a synthetic-based, water soluble drawing / finning lubricant and a hot water rinse. The changes were based on an increasingly reported rate of pitting failures, and the similarity of their failures compared to those reported by the Japanese relating to ant nest corrosion.

Laboratory studies, as described above, were performed on a sample of the drawing / finning lubricant used at the tube manufacturing mill. The tests produced blue-black and black stains on the surfaces and branched tunneling was revealed from the cross-sections. These results confirmed the suspicion that the stains were present when received from the mill and that this was a lubrication related failure.

Figure 7. Cross-section of evaporator tube. (ID is at top). Note the near through-wall penetration of the tunnels. Pit originates on ID surface, top. (60X original magnification)
